Manhole Inspection Summary

Manhole # S09EE2014MH

Insp Date: **10/6/06 9:07 AM**

Location Address: **2500 GREENSPRING AVE**

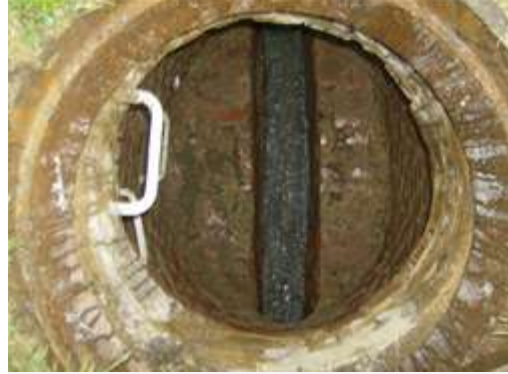
Top View

Frame leaks. Frame offset. Adjustment deterioration and infiltration. Barrel infiltration. Evidence of surcharge - Bench

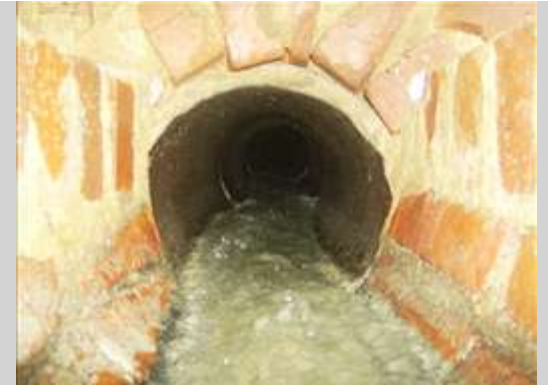
10 in. Circular Gravity Sewer Pipe Out @ 12 O'Clock

Infiltration: **Evidence** Pipe Seal Cond: **Unknown**

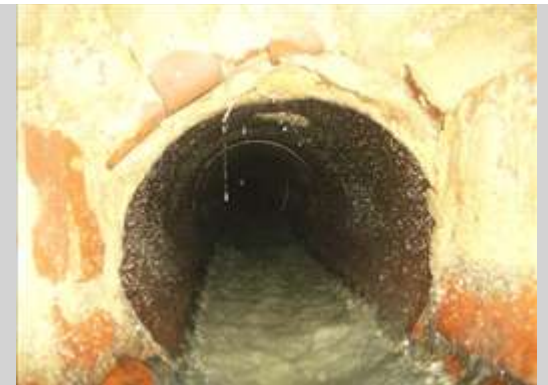
10 in. Circular Gravity Sewer Pipe In @ 6 O'Clock

Infiltration: **Evidence** Pipe Seal Cond: **Unknown**
